SUBJECT: CLEAN AIR ACT INSPECTION REPORT
St. Paul Regional Water Services, Maplewood, Minnesota

Facility Name: St. Paul Regional Water Services

Facility Location: 1900 Rice Street, Maplewood, Minnesota

Date of Inspection: December 5, 2022

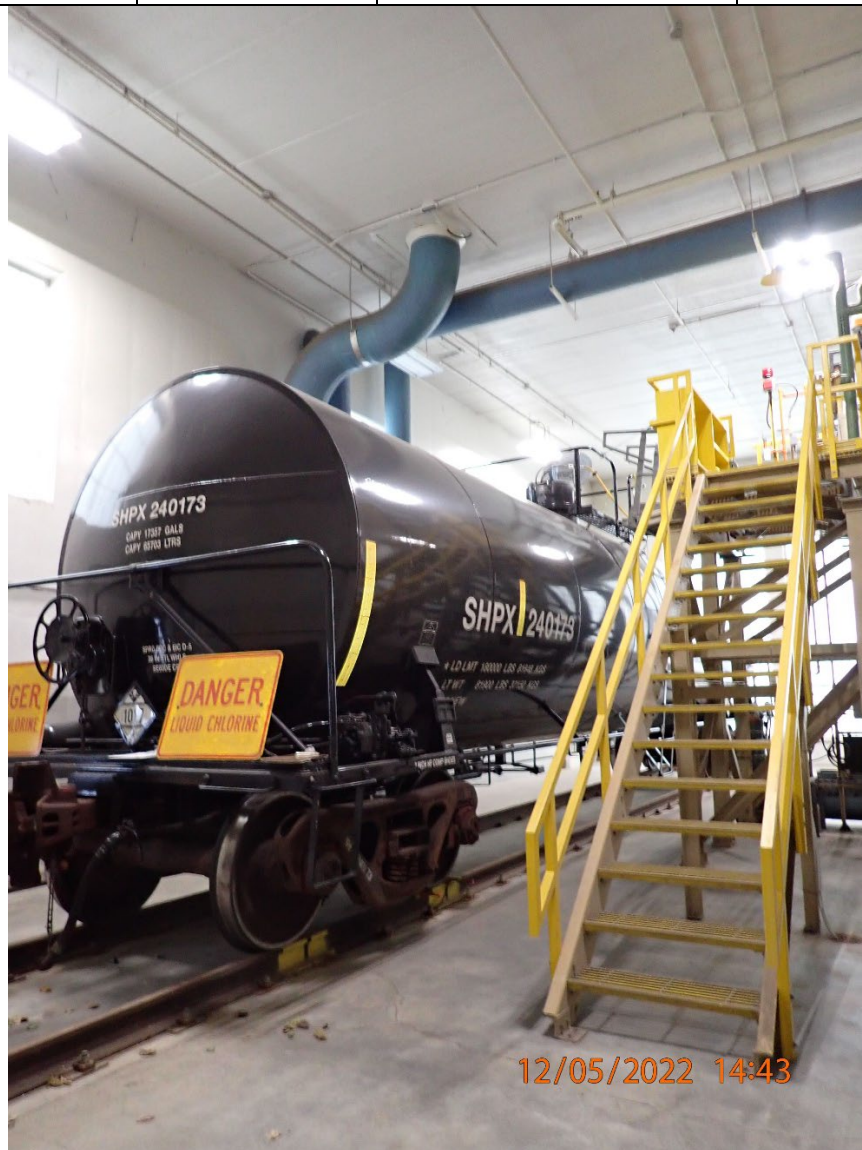
Image Number	File Name	Date and Time	Description of Image
1	PC050050	12/05/2022 14:43 hrs	Chlorine rail tank car bay

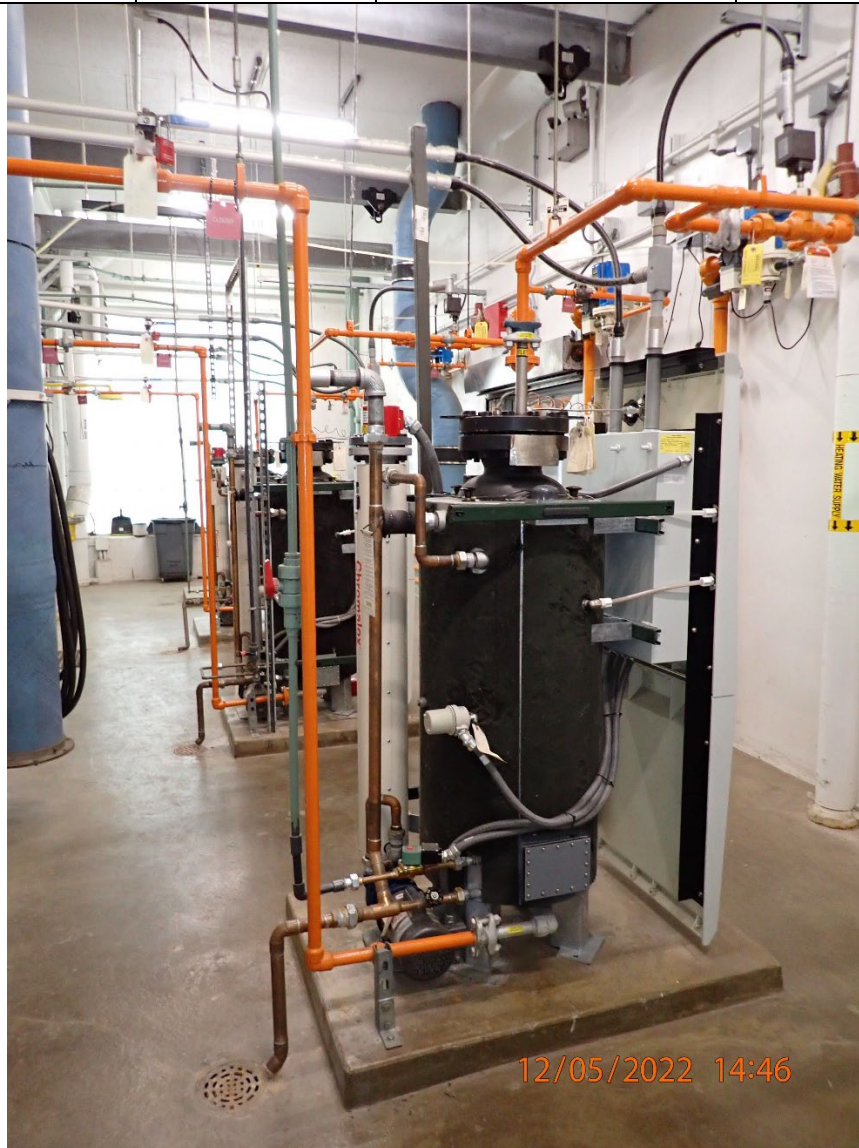
Image Number	File Name	Date and Time	Description of Image
2	PC050051	12/05/2022 14:46 hrs	Chlorine evaporators

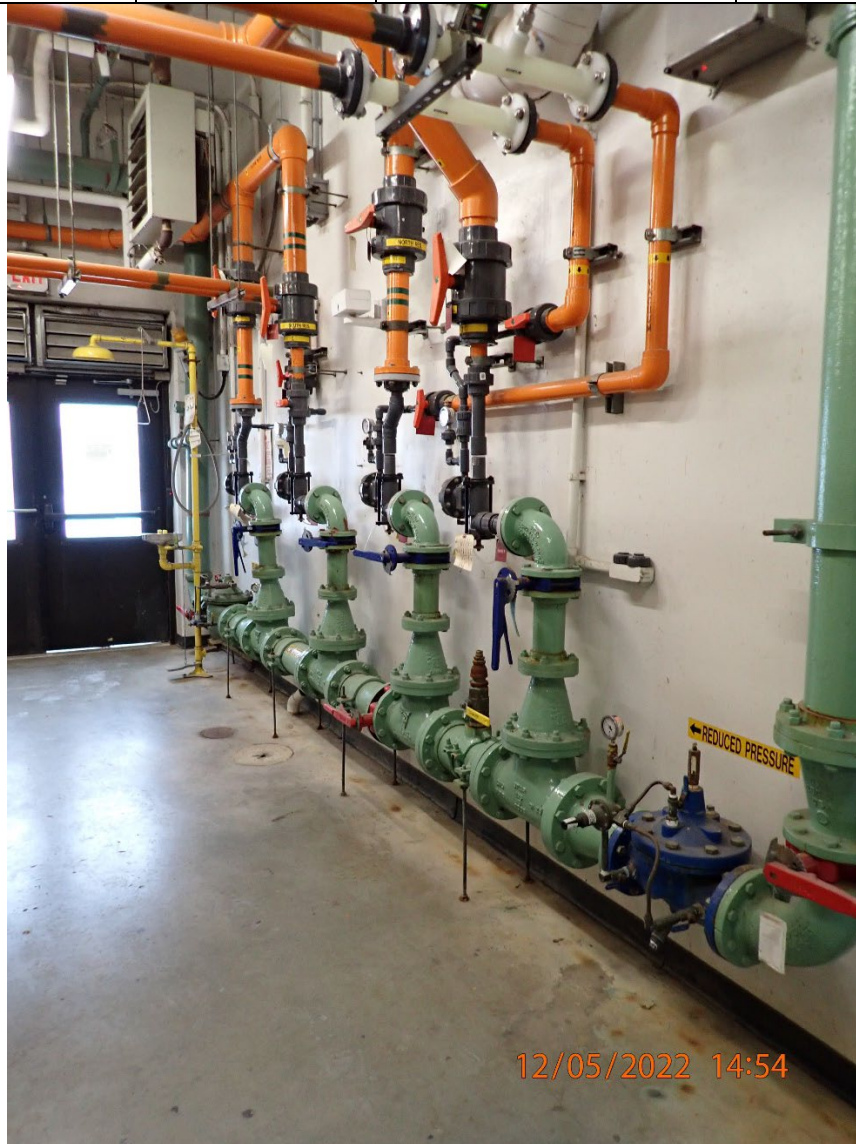
Image Number	File Name	Date and Time	Description of Image
4	PC050053	12/05/2022 14:54 hrs	Chlorine injectors

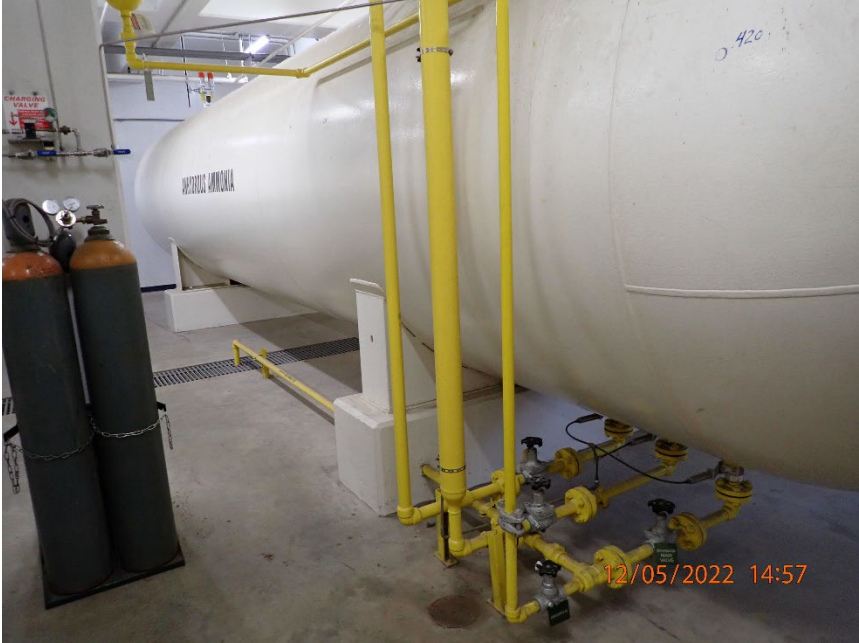
Image Number	File Name	Date and Time	Description of Image
5	PC050054	12/05/2022 14:57 hrs	South ammonia bullet

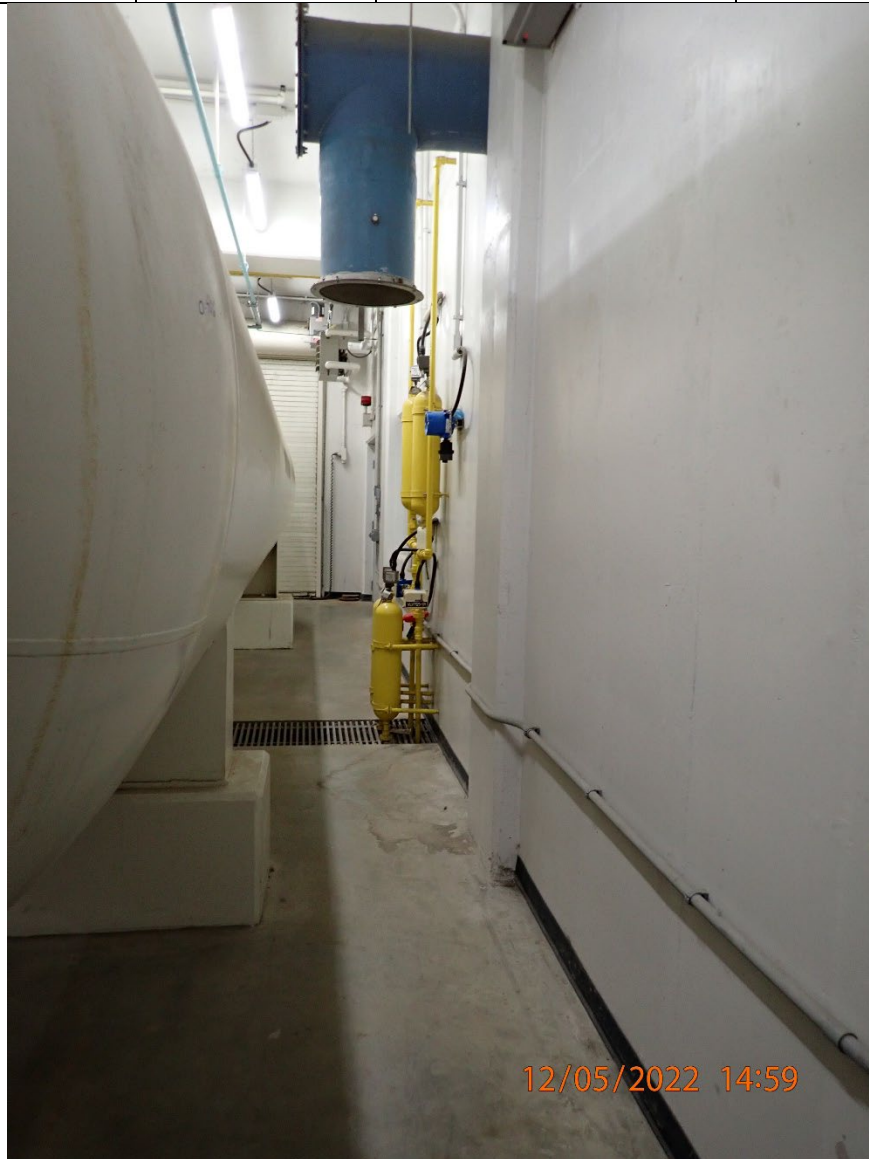
Image Number	File Name	Date and Time	Description of Image
6	PC050055	12/05/2022 14:59 hrs	North ammonia and sensor
